Technical Consultation on Corrosion in Fertilizer Plants

COUNTRY PAPER FROM KUWAIT

CORROSION PROBLEMS EXPERIENCED IN AMMONIA AND UREA PLANTS*

Bahaa H. Abdel Nabi **

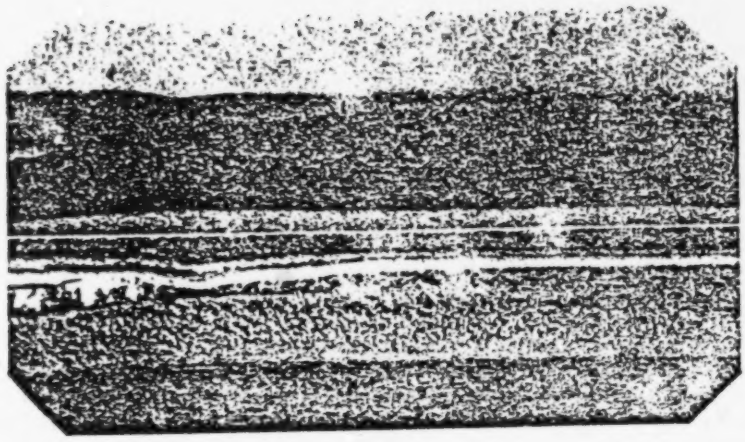
Photo 1 : View of external surface.

The whole area was covered with brown scale. Widely spread uneven corrosion was seen longitudinally and it was bitter (Photo 1).

3.2. Corrosion of outside due to ammonia generated by decomposition of amines (morphaline) or ammonia which added for neutralization of boiler feed water.

4.1. Modifying tubes material of the surface condensers. Both Cu/Ni 70/30 and Titanium were put under investigation as alternative materials.

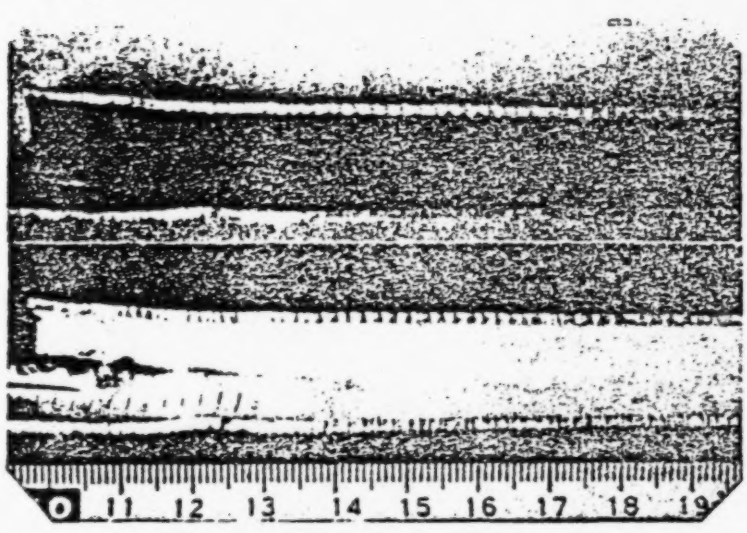
Photo 2 : View of internal surface.

The whole area was covered with brownish black scale. After descaling leakage was found to take place longitudinally and no significant corrosion was observed in other areas. See Photo (2).

3.1. The Aluminium Brass tubes are considered not suitable a material in our condensers from design and actual operation point of view. As the sea water velocity is excessive enough to cause impingment attack to the tubes material from inside.

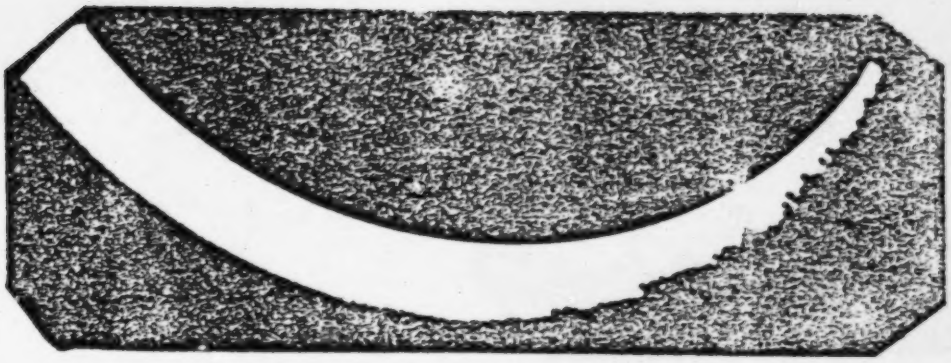
The view of cross section and microscopic observation of longitudinal and circumferential cross section at the leaked and corroded part are shown in Photo 3 & 4. The leakage is caused evidently by the corrosion of outside. However inside of tube, very slight corrosion is recognized as shown Photo (4-d).

Photo 3 A: Leaked part circumferential.

Photo 3 B: Corroded part longitudinal.

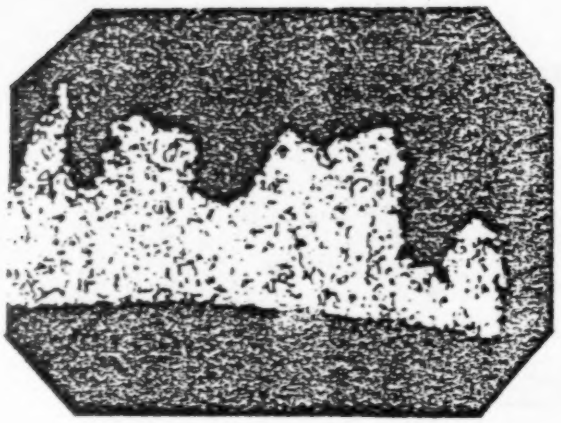
Photo 4 A: End point of leaked part shown in Photo 18A.

Photo 4 B: Corroded part shown in 18 B.

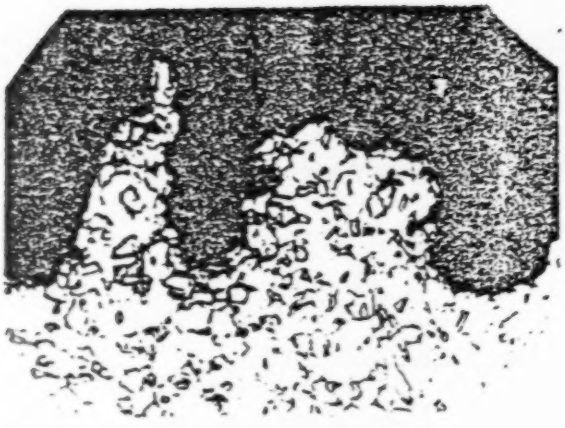
Photo 4 C: Corroded part shown in photo 18 B.

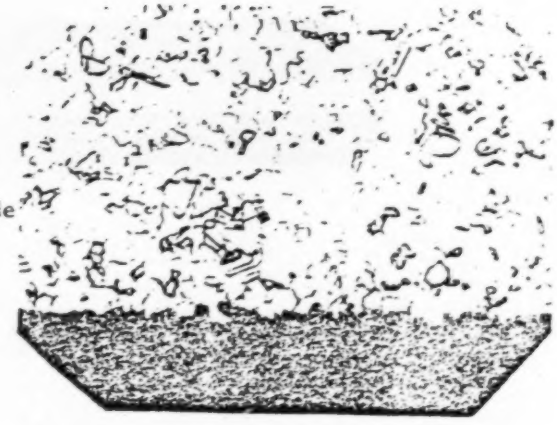
Photo 4 D: Slight corroded part of inside.

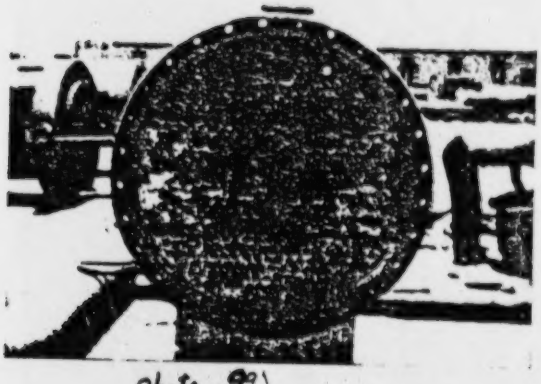
Photo 1)

West Tube sheet Before cleaning.

Heavy corrosion products and sea water salts.

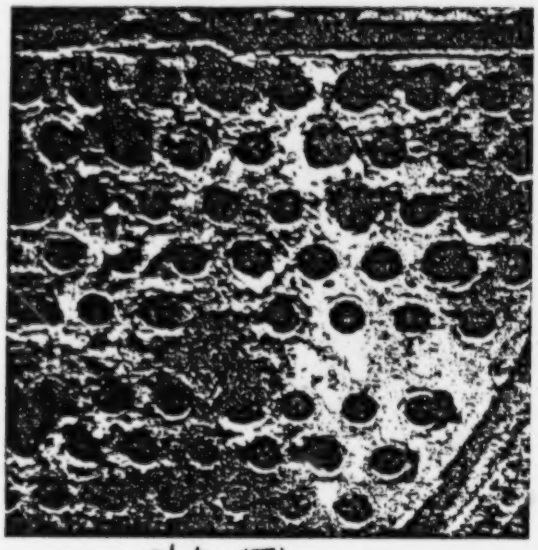
photo 2)

East Tube sheet before cleaning.

Notice the difference between the amount of salt deposits on East and west tube sheets.

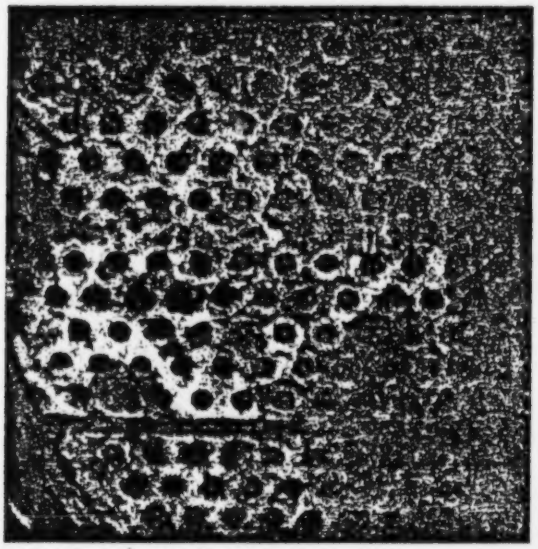
photo (3)

West Tube Sheet after cleaning.

Notice the corroded grooves around the tube ends, and the tube end which completely eaten out.

4.3. All tubes ends were over expanded with special care to leaking ones which were plugged. The corroded grooves on tube sheet and corroded tubes ends to be filled by welding using Monel 67 filler wires and gas welding.

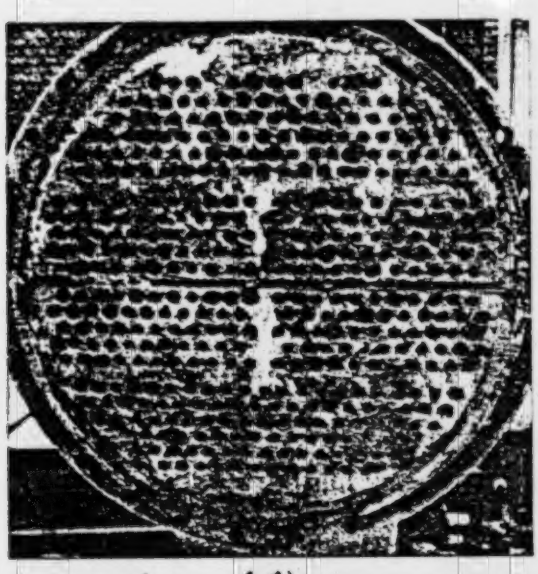
photo (5)

The sea water containing leaked ammonia attacked the Cu/Ni layer on the tube sheets at both condenser ends. This attack is remarkably increased in the order from the 1st to the 4th passes with the exception of the main sea water inlet and outlet at the east side. This is due to that at the inlet the sea water is free from ammonia while at the main outlet the ammonia contaminent in sea water has been consumed in the corrosion reactions with copper and precipitation of sea water salts. (See Fig. 4).

East Tube Sheet after cleaning:

Notice the absence of corrosion in Main Inlet and outlet of Sea Cooling water.

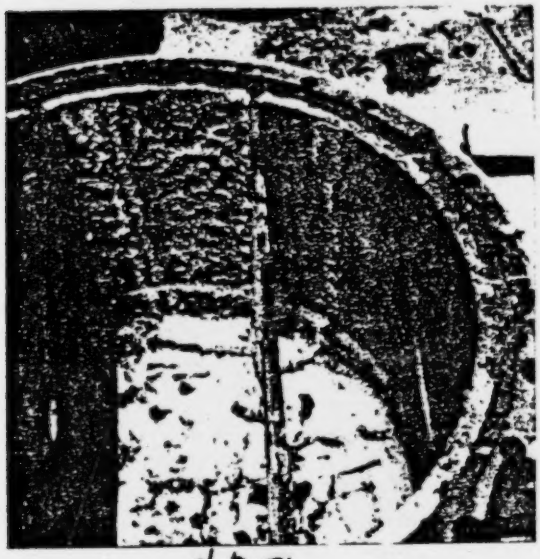
photo 7)

Partition plates edges were found severely corroded at their contact with the tube sheet as illustrated in Photo No. 7. A luster film of crystalline deposits green in colour were found adherent to the internal surface of bonnet between its two partition plates i.e. in the 2nd and 3rd flow passes as illustrated in Photo No. 8.

2.1.4. The three Magnesium anodes fixed on the partition plates of the east Bonnet were found completely missed and the supporting bolts were corroded out. One of the bolts was found completely mis sed leaving a hole at its position. (See Photo No. 7).

The potential difference exists between the partition plates made of carbon steel and the tube sheets of Cu/Ni on contact with each other after peeling off of coating and anodes consumption produced electron flow between them.

Thus corrosion start and continued on the less corrosion resistant metal (Carbon steel of the partition plate - anodic) caused it to be eaten out.

East Bonnet

Galvanic corrosion on the partition plates edges at their contact with the tube sheet after peeling of coating. Notice the hole at position of the supporting bolts of Magnesium anode.

4.1. Magnesium anodes should be replaced by Zinc alloy anodes "C-sentry" which are the suitable and efficient anodes for cathodic protection in sea water medium. Bakelite or rubber washers should be fixed under the bolt heads and nuts to avoid galvanic corrosion of partition plates. However study and evaluation in hand to use Aluminium anodes which is better than Magnesium anodes in sea water service.

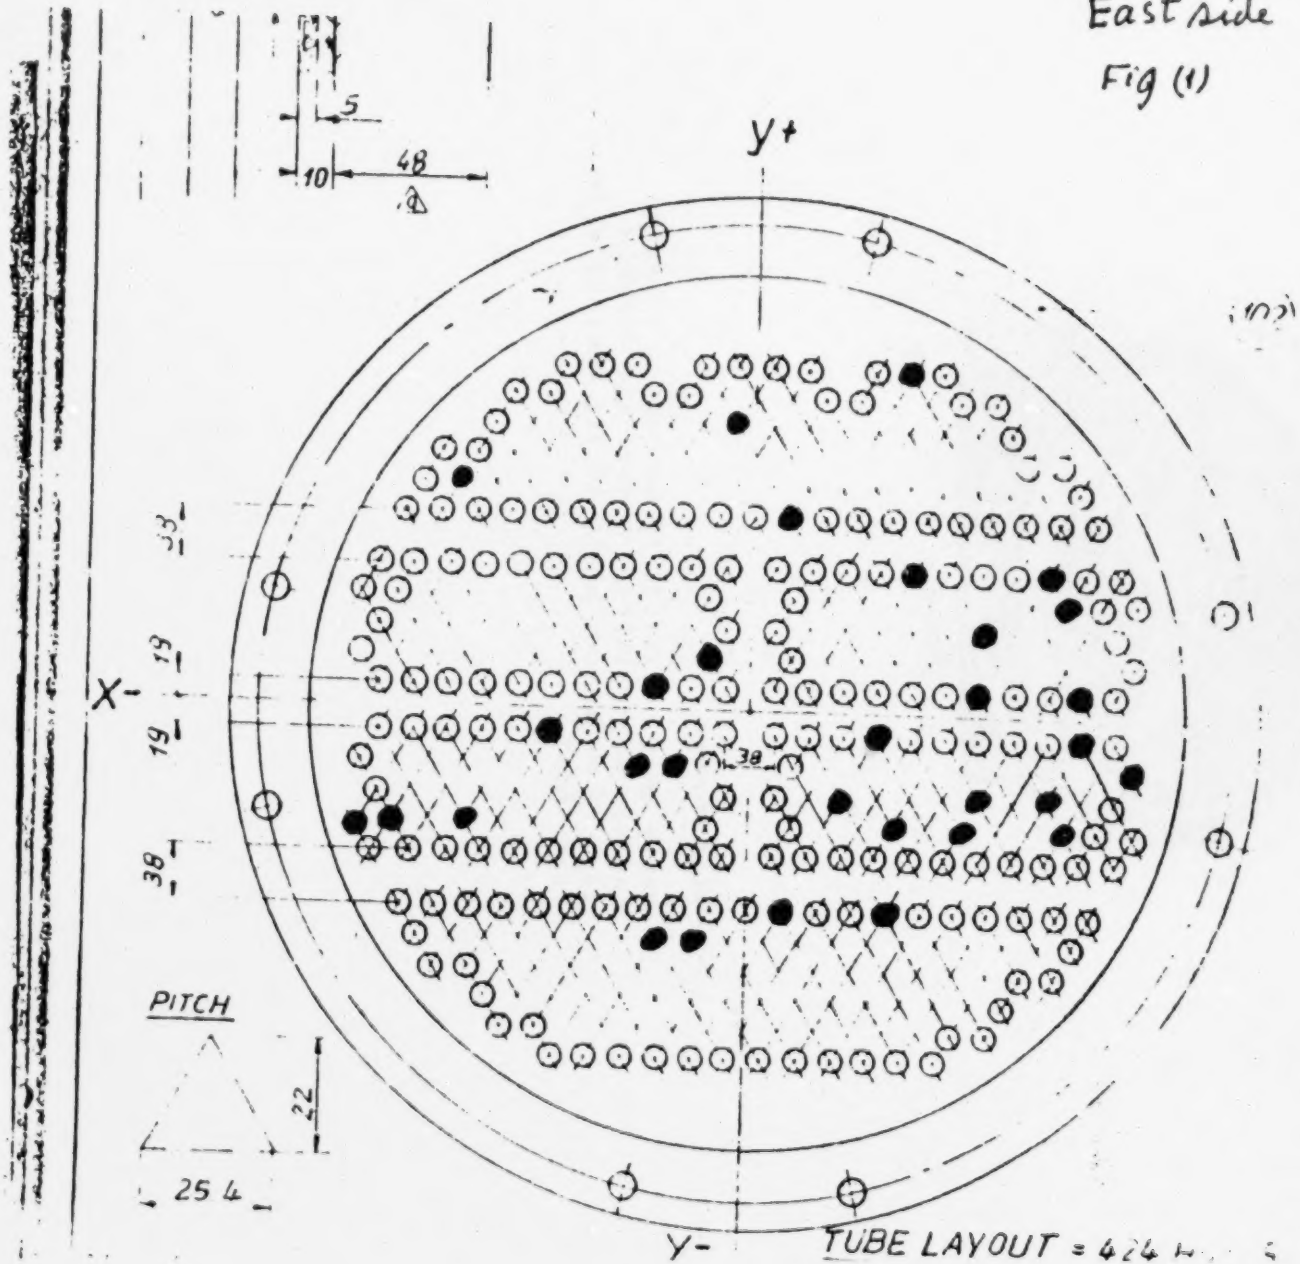
Fig (1)

2.1.5. Pressure test was carried out at 23 Kg/cm^2 using water detecting agent, water was found to seep from around 31 tubes on east side and 18 tubes on west side as shown in figures (1) and (2).

4.2. Pressure test with the application of water detecting agent should be carried out on any new condenser before putting on line to check that proper expanding has been done by the Manufacturer in case of rolled to tube sheet tubes arrangement.

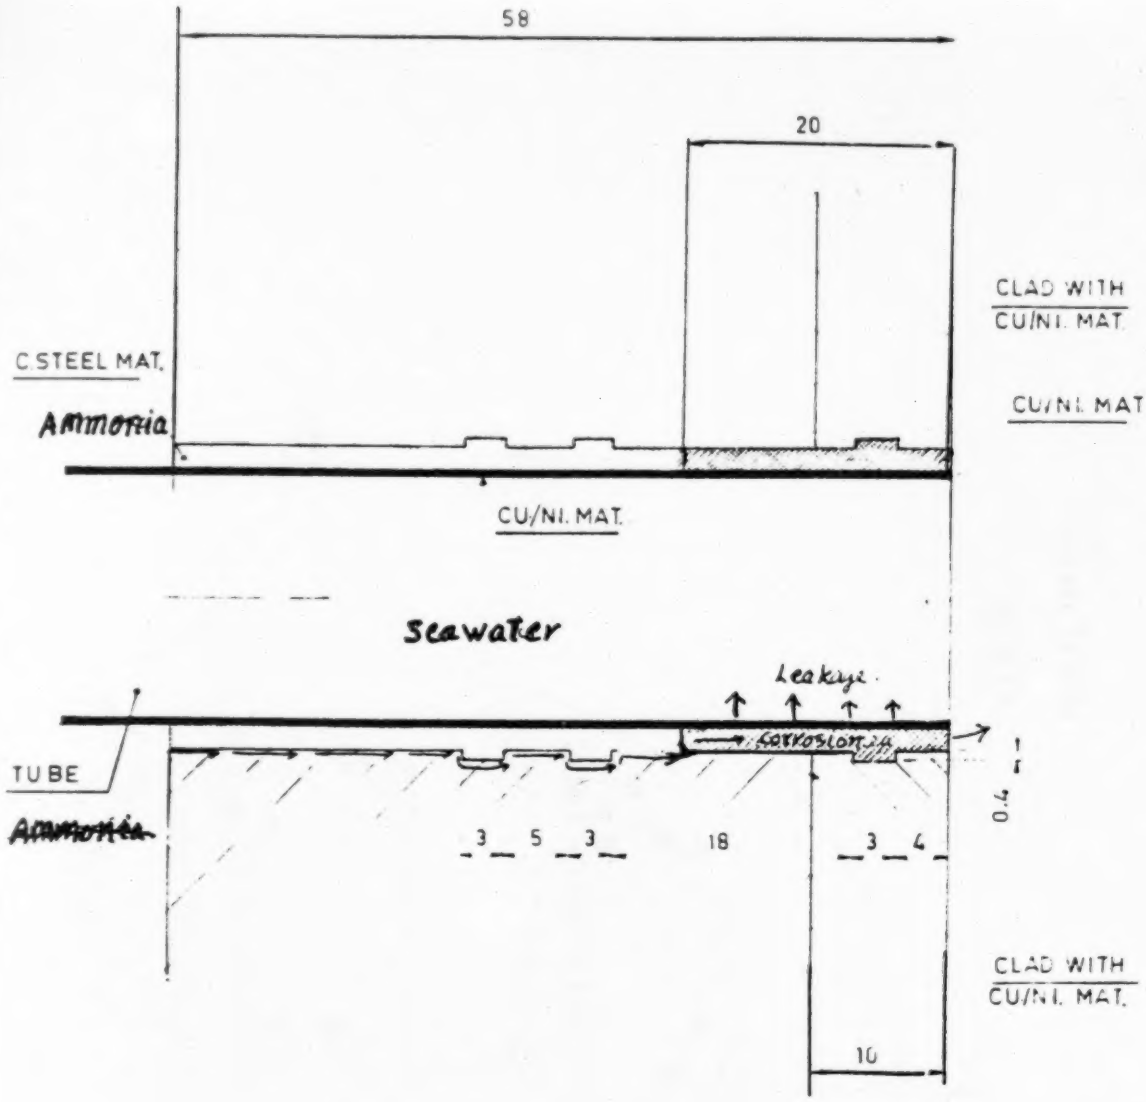
Fig (3)

From the attached drawing No. (3) of tube end arrangement it is clear that the outer surface of the tube end inside the tube sheet consists of two metals carbon steel and Cu/Ni 70/30 of 20 mm. length to avoid contact of sea water with carbon steel. Ammonia may be leaked from a point of bad expanding till it became in contact with Cu/Ni material of outer tube end. Then severe corrosion took place on the Cupro Nickel outer tube surface and on the outer surface of the inner Cu/Ni tube causing ammonia leakage to sea water.

4.4. New design of tube end illustrated in Fig. (3) is to be revised for future arrangement.

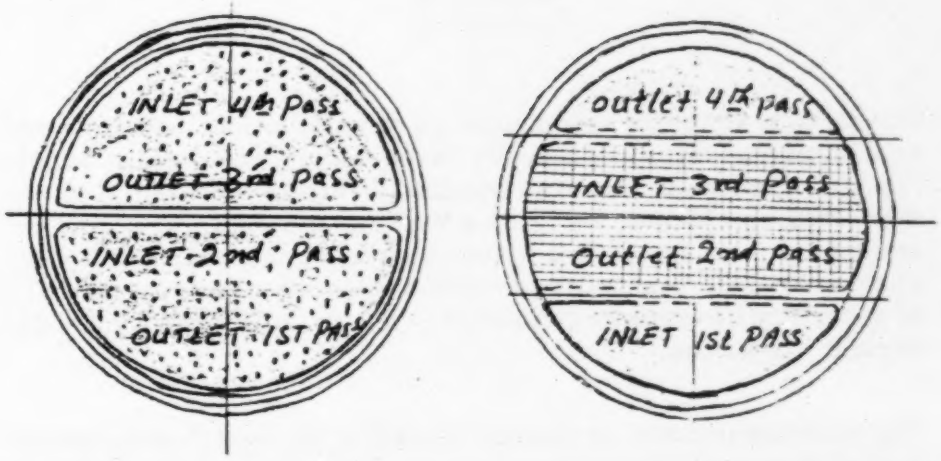
No to very low: Signs of Corrosion and Salts deposition.

Medium: Corrosion and Salt deposition

High Corrosion area and heavy Salts deposition.

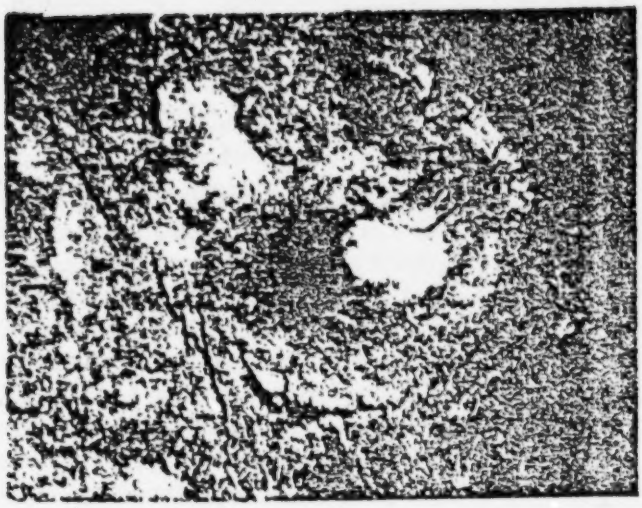
1- 5.25 X

Examination of the removed strip revealed a deep (mechanical) dent on the back surface of the strip (Macrograph No. 1). A series of branched cracks were found spread all over the back surface of the strip (Macrographs No. 2).

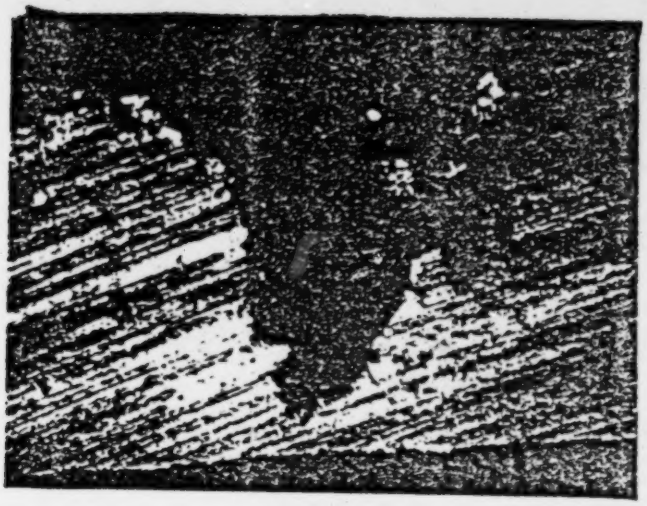
3- 13 X

The strip was from bulged and removed liner and was removed as a preventive action. Back side of removed strip was found severely subjected to corrosion attack on local areas. A cross section midway one of corrosion pits is shown in Macrograph (3).

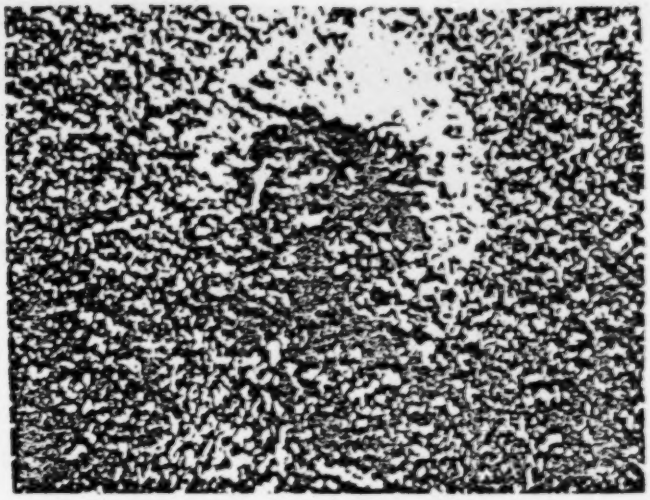
11 – 16.8X

- Cracking immediately adjacent to weld beads See Macrograph No. (4).
- Corrosion attack across weld deposits was noted mostly at top start points of the weld. Macrograph No. (5).
- Cracking in the parent metal close to welds heat affected zones.
- Deep corroded holes and cuts in welds heat affected zones. Macrographs No. 6 - 9. Corrosion and surface blisters on parent metal of the strip were also noted. Macrographs No. 10 & 11.

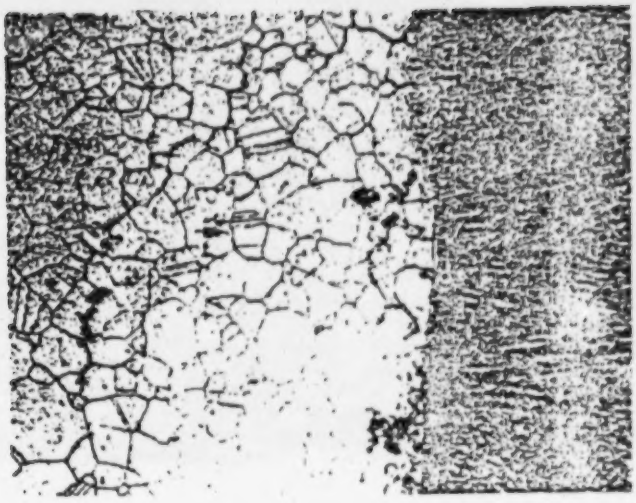
27— 64X

- Corrosion and/or cracking of strip material developed mostly in vicinities close to weld joints as shown in Macrographs Nos. 26 - 28. Cracks were noted to penetrate through weld metal as Micrographs Nos. 29 - 31).

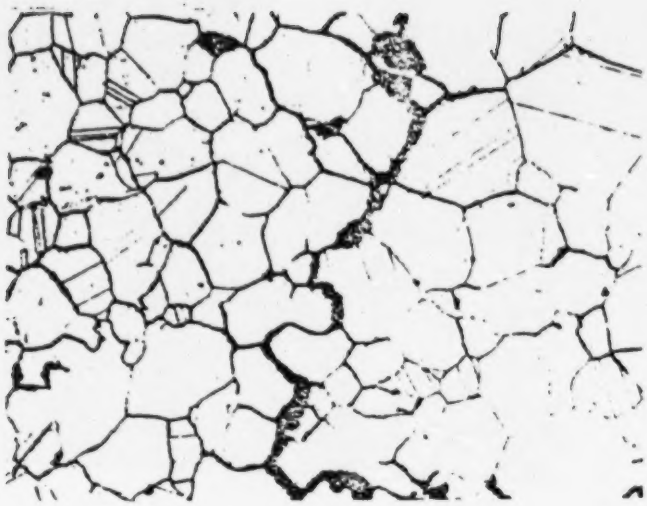
33- 100 X

- Cracks displayed intercrystalline mode of progression as shown in Micrographs Nos. 32 - 34.

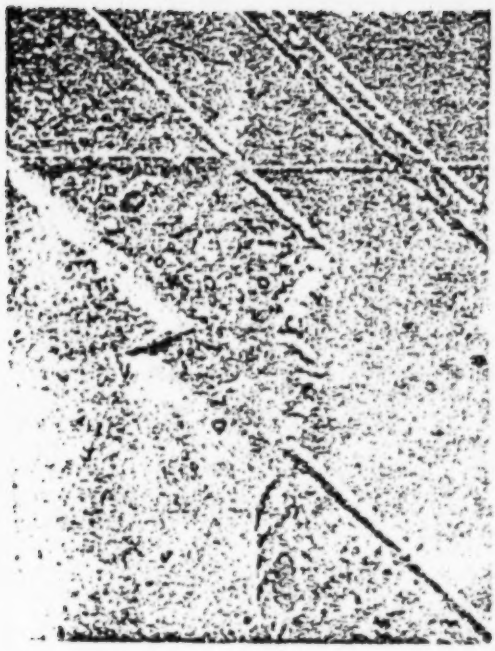
35- 1280 X

- Signs of grain boundary sensitization were noted in areas confined to heat affected zones of welds (Micrographs Nos. 35, 36). Dispersed precipitate was noted at austenite grain boundaries ahead of propagating cracks.

This type of cracking can be occured when stainless steel contains more than 0.03% C. and not stabilized by Niboium or Titanium and that it has undergone thermal processing (Welding or heat treatment) in the so called sensitization range (500° C - 800° C).

6.3. For future orders of lining m aterial, suppliers will be asked to submit mater ial test certificate and Huey test results. The remaining bridge strips that were not replaced during the last repair job have to replaced.
